# Illinois Department of Transportation

## Memorandum

To: Tom Sancken  
From: Kenneth R. Lang *KL* By: Terry McCleary  
Subject: Pavement Cores\*  
Date: April 27, 2004

\* I-80 from Ottawa to Seneca

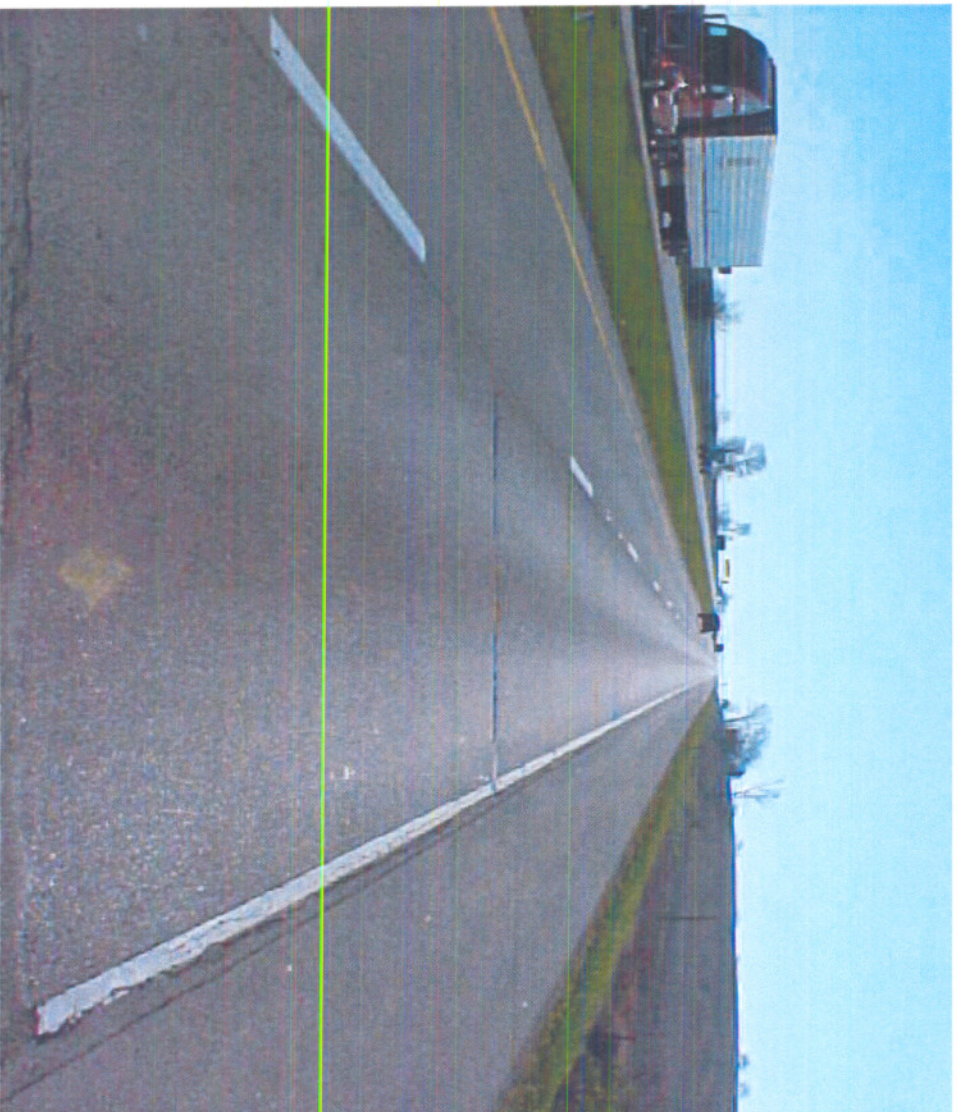
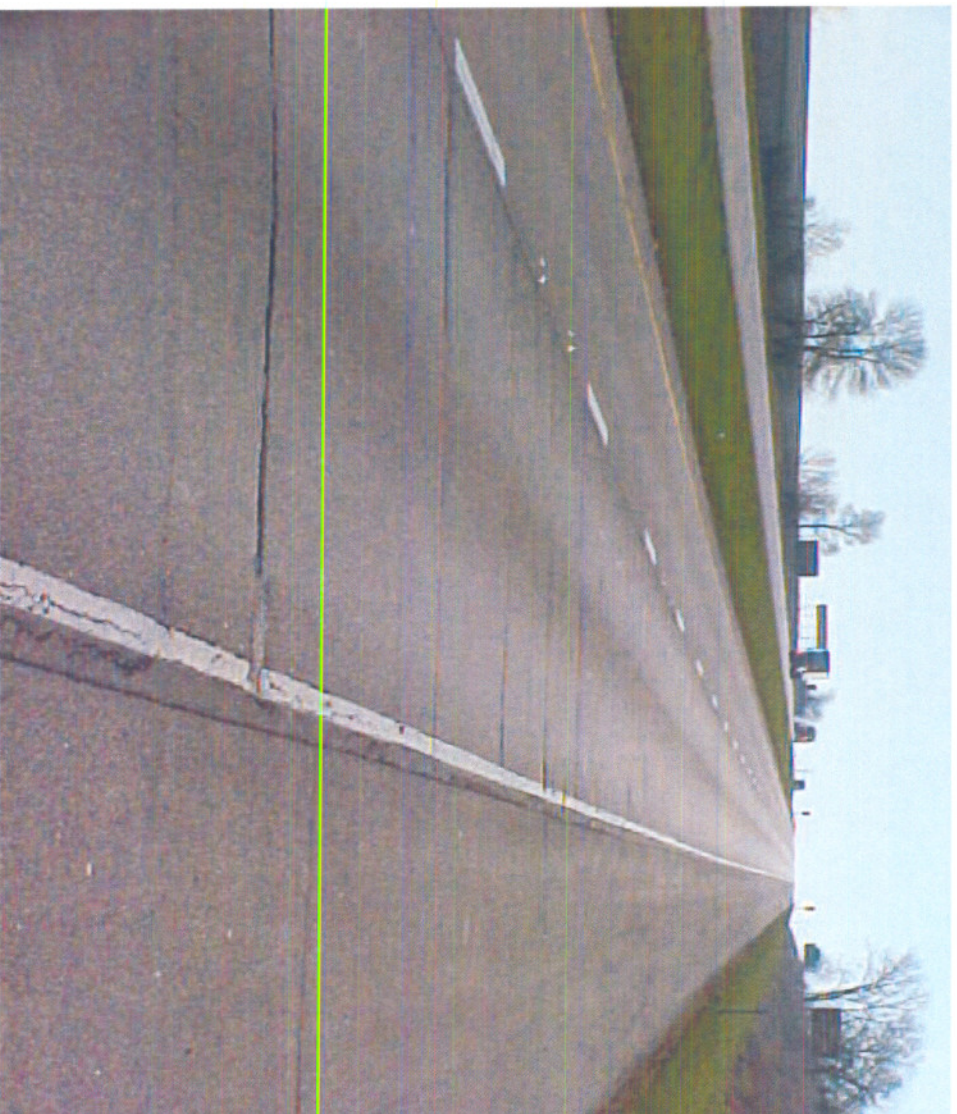
# I-80 MP 96.1 EBDL Core 3A

- Core #1 EBDL MP 94.2  
2 7/8" Bituminous Surface Course in Good Condition  
2" Bituminous Binder Course in Good Condition  
No Bond  
9" PCC in Poor Condition  
IBV=4.7
- Core #2 EBDL MP 95.2  
3 1/8" Bituminous Surface Course in Good Condition  
2" Bituminous Binder Course in Good Condition  
No Bond  
9 1/4" PCC in Good Condition  
IBV=3.6
- Core #3A EBDL MP 96.1  
1 1/2" Bituminous Surface Course in Poor Condition, Stripping  
No Bond  
11 1/2" PCC in Good Condition – Patch
- Core #3B EBDL MP 96.1  
13" PCC in Poor Condition – Top of core broke up  
IBV=4.5
- Core #4 EBDL MP 98.3  
2 1/4" Bituminous Surface Course in Good Condition  
2 1/4" Bituminous Binder Course in Good Condition  
10 1/4" PCC in Poor Condition – Broken in two pieces at 6" down.  
IBV=4.2

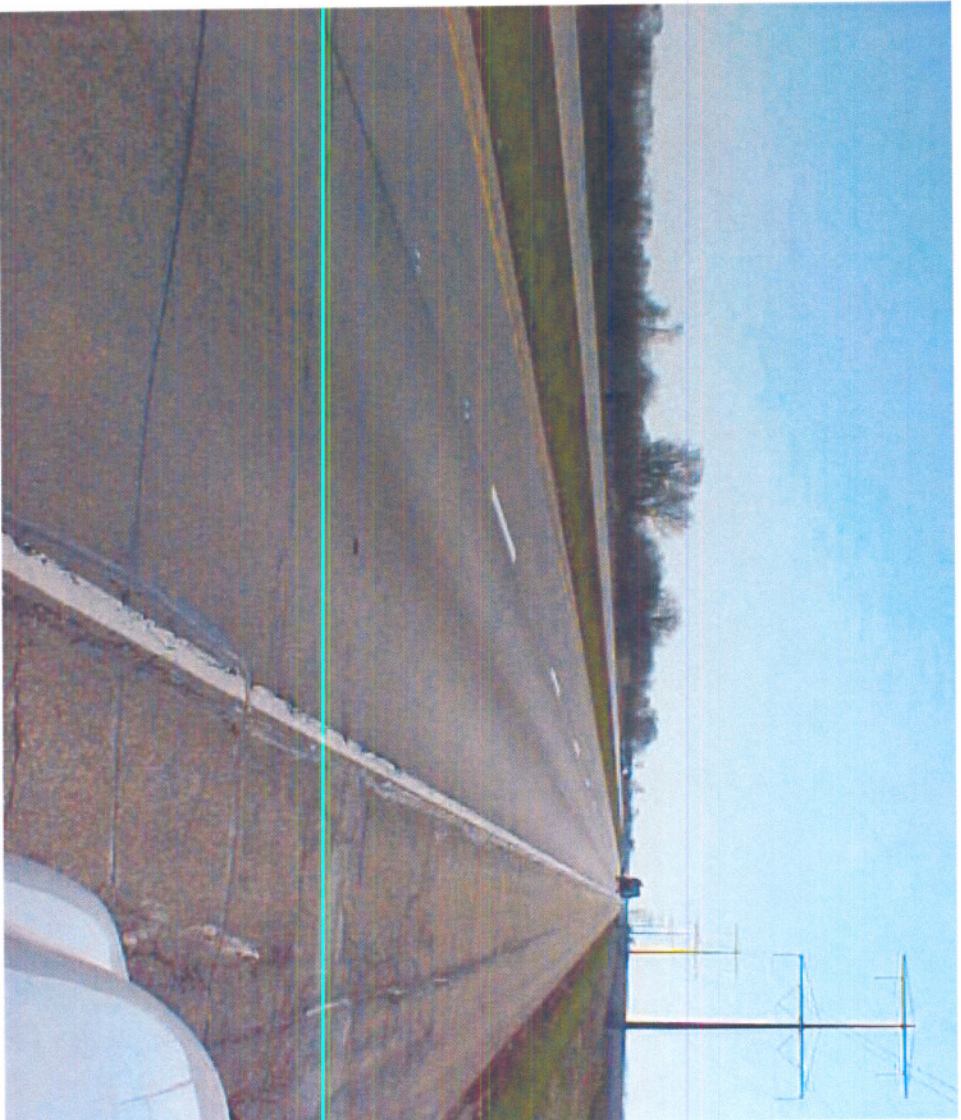
# I-80 MP 103 EBDL Core 10

Core #5	EBDL MP 98.6 3 ¼" Bituminous Surface Course in Good Condition 1 ¼" Bituminous Binder Course in Good Condition No Bond 9½" PCC in Good Condition IBV=4.0
Core #6	EBDL MP 99.6 2 ½" Bituminous Surface Course in Good Condition 11" PCC in Good Condition – Patch IBV=4.2
Core #7	EBDL MP 100.6 2 ¾" Bituminous Surface Course in Poor Condition 11 ½" PCC in Poor Condition IBV=2.9
Core #8	EBDL MP 101 2" Bituminous Surface Course in Good Condition 13 ¼" PCC in Good Condition – Patch IBV=9.0
Core #9	EBDL MP 102 3 ½" Bituminous Surface Course in Good Condition 1 ½" Bituminous Binder Course in Good Condition 10 ¼" PCC in Good Condition IBV=8.0
Core #10	EBDL MP 103 2 ¼" Bituminous Surface Course in Good Condition 2 ¼" Bituminous Binder Course in Good Condition 10 ¼" PCC in Poor Condition – Badly cracked IBV=11.0
Core #11	EBDL MP 104.4 4 ½" Bituminous Surface Course in Good Condition ¼" Bituminous Sand Mix in Fair Condition ? PCC in Poor Condition – Retrieved in many pieces IBV=4.6

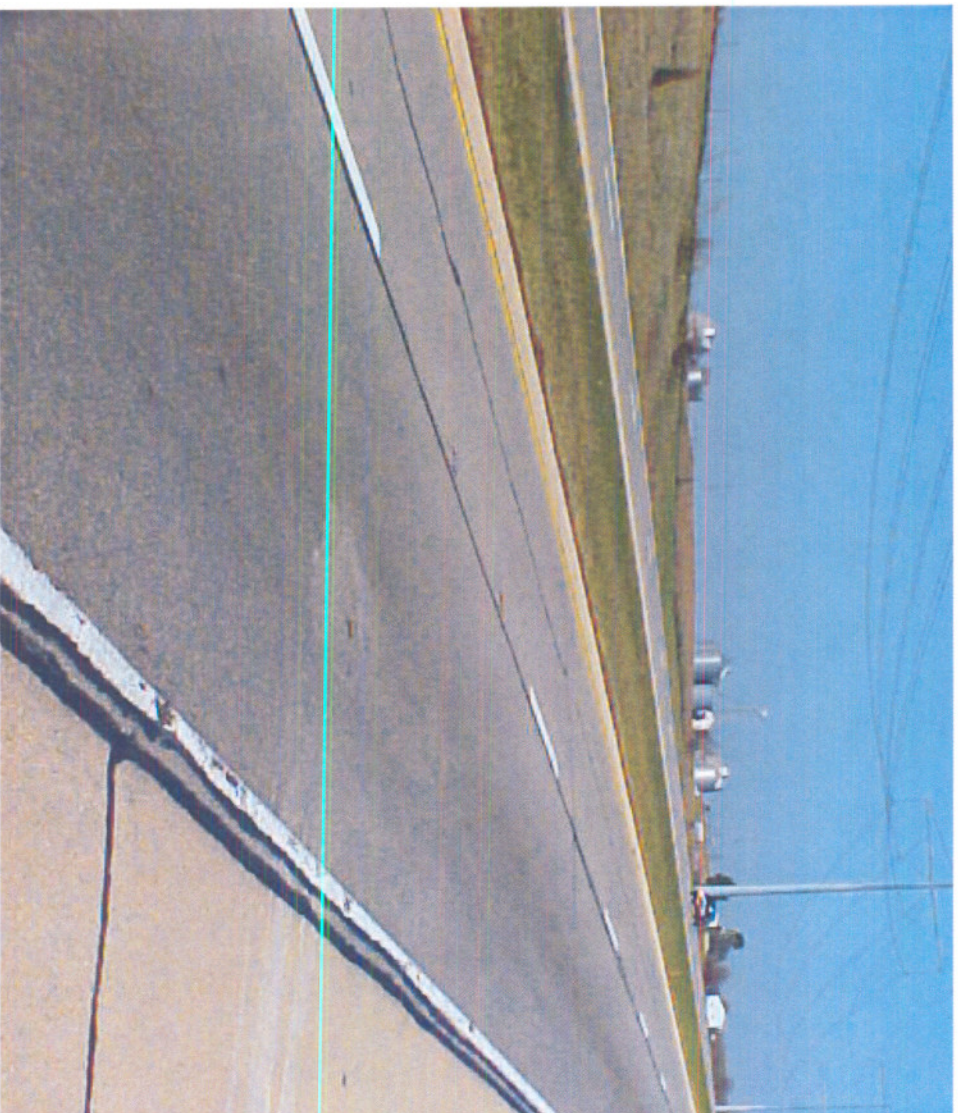
# I-80 MP 102.5 WBDL Core 12

Core #12	WBDL MP 102.5 3 ½" Bituminous Surface Course in Good Condition 1 ½" Bituminous Binder Course in Good Condition No Bond 10" PCC in Poor Condition – Broken in two pieces at 9" down. IBV=3.7

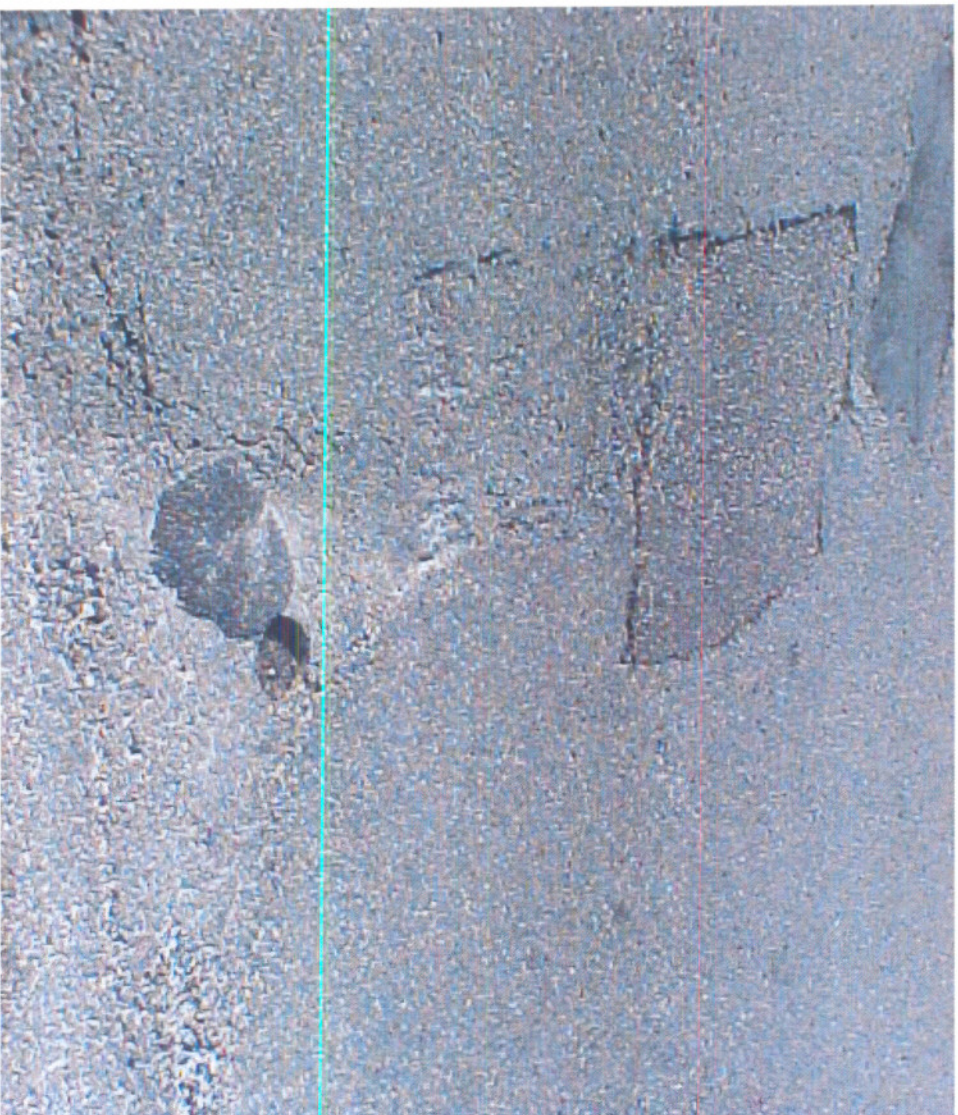
# I-80 MP 96.2 WBDL Core 16

- Core #13    WBDL MP 101.5  
3 1/2"    Bituminous Surface Course in Fair Condition  
1 3/4"    Bituminous Binder Course in Fair Condition  
No Bond  
10"    PCC in Good Condition  
IBV =10.5
- Core #14    WBDL MP 99  
3 1/4"    Bituminous Surface Course in Good Condition  
1 1/2"    Bituminous Binder Course in Good Condition  
10"    PCC in Good Condition  
IBV=7.0
- Core #15    WBDL East of Marseilles off ramp near MP 97  
2 1/2"    Bituminous Surface Course in Good Condition  
1 1/2"    Bituminous Binder Course in Good Condition  
10"    PCC in Good Condition  
IBV=3.5
- Core #16    WBDL MP 96.2  
1 1/2"    Bituminous Surface Course in Very Poor Condition  
10"    PCC in Good Condition
- Core #17    WBDL MP 95.4  
?"    Bituminous Surface Course in Very Poor Condition  
11"    PCC in Poor Condition – Badly cracked patch
